National Transportation Safety Board

Safety Recommendation

Date: October 7, 1998

In reply refer to: A-98-87

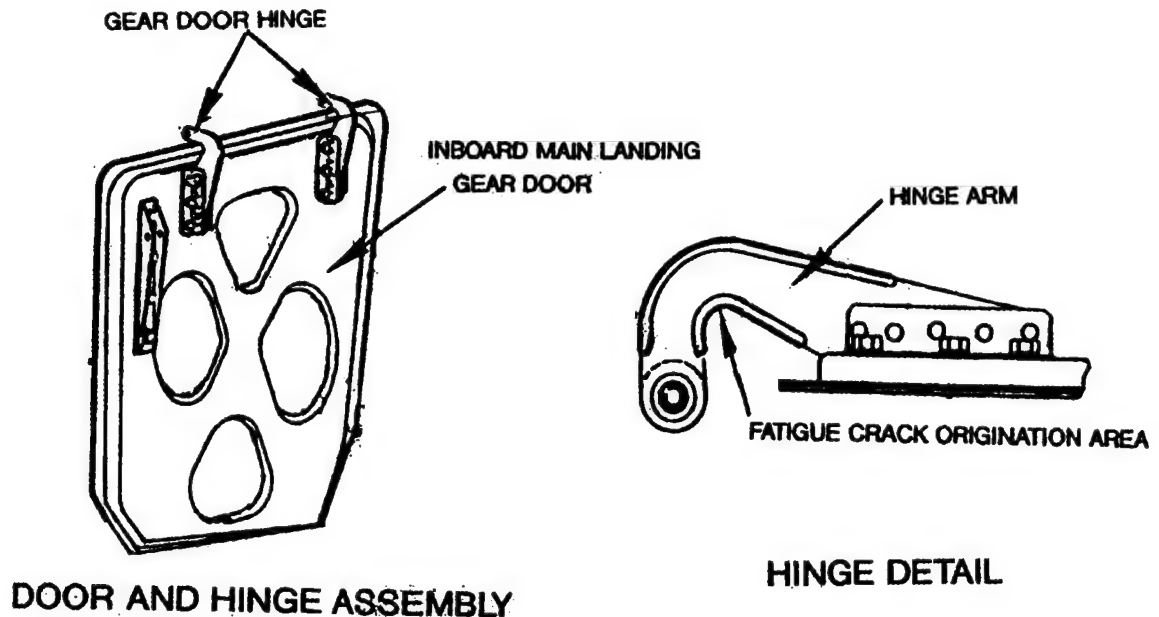
Figure 1. Piper PA-31 Main Landing Gear Door Assembly

arm (see figure 1). The arm is subjected to cyclic loading during service, and the forging flash is a high-stress region of the hinge.

In 1980, following several incidents of fatigue cracks in the original hinge, Piper Aircraft Corporation (now New Piper Aircraft, Inc.) issued Service Bulletin (SB) 682, which recommends inspection of the PA-31 MLG inboard door hinge assemblies and hinge attachment angles for cracks within the first 100 hours of operation or during the next scheduled inspection, whichever occurs first, and every 100 hours thereafter unless/until an acceptable replacement part is installed. The SB recommends that all cracked door hinges be replaced with the improved P/N 47529-32 hinge assemblies before further flight. Upon installation of the improved hinge assembly, repetitive inspection of the hinge assembly is not required. On December 19, 1980, the Federal Aviation Administration (FAA) issued Airworthiness Directive 80-26-05, mandating the actions specified in this SB.

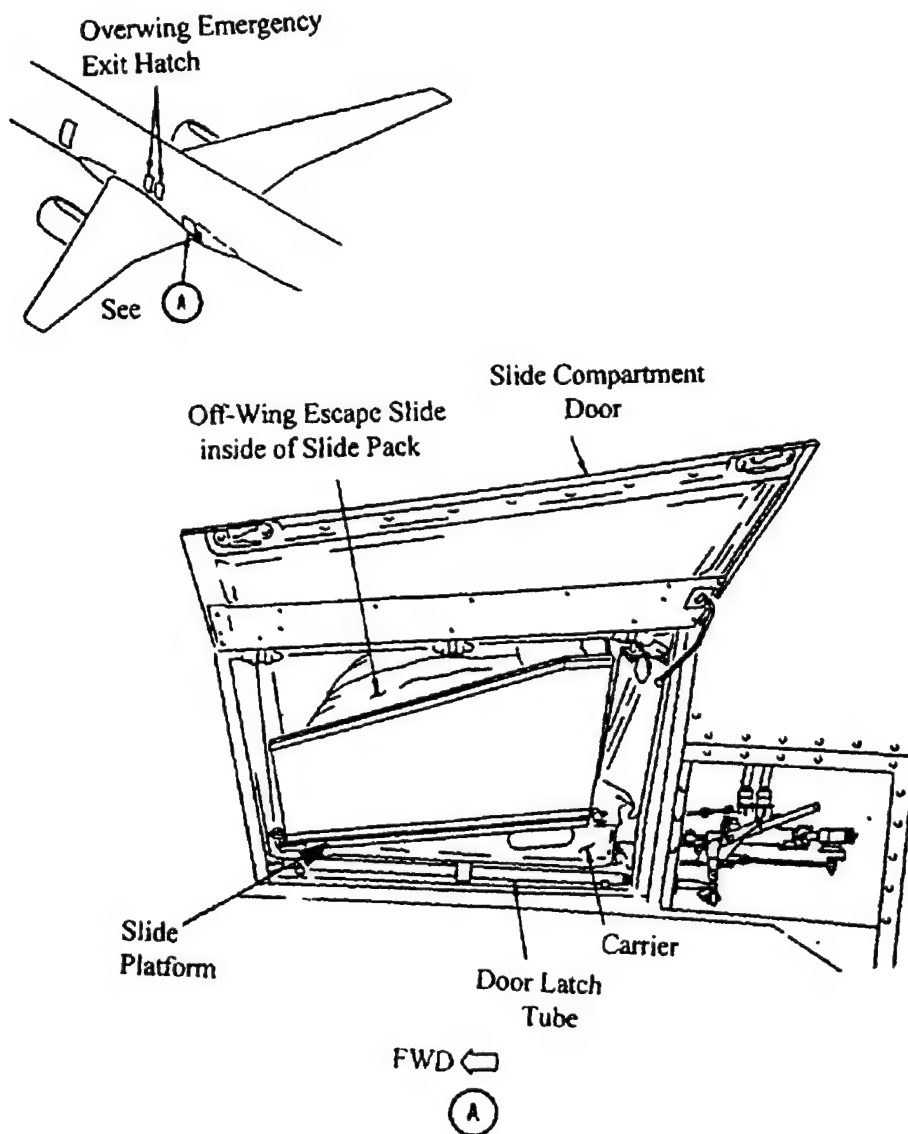
Figure 1.—B-757 Off-Wing Escape Slide Assembly

down position, stating that "it took several attempts to move the actuator handle to the latched position." The mechanics stated that after the door was latched one mechanic ran his finger around the door to ensure it was closed, and then both mechanics checked the EICAS in the cockpit to ensure that the door was closed. One of the two mechanics said that he had received instructions on how to replace the slide about 4 or 5 years ago during a 2-week B-757 initial maintenance training class that provided instructions on all B-757 systems. The other mechanic had not yet received training on the B-757 off-wing escape slide replacement during his 3 months of employment at Delta.

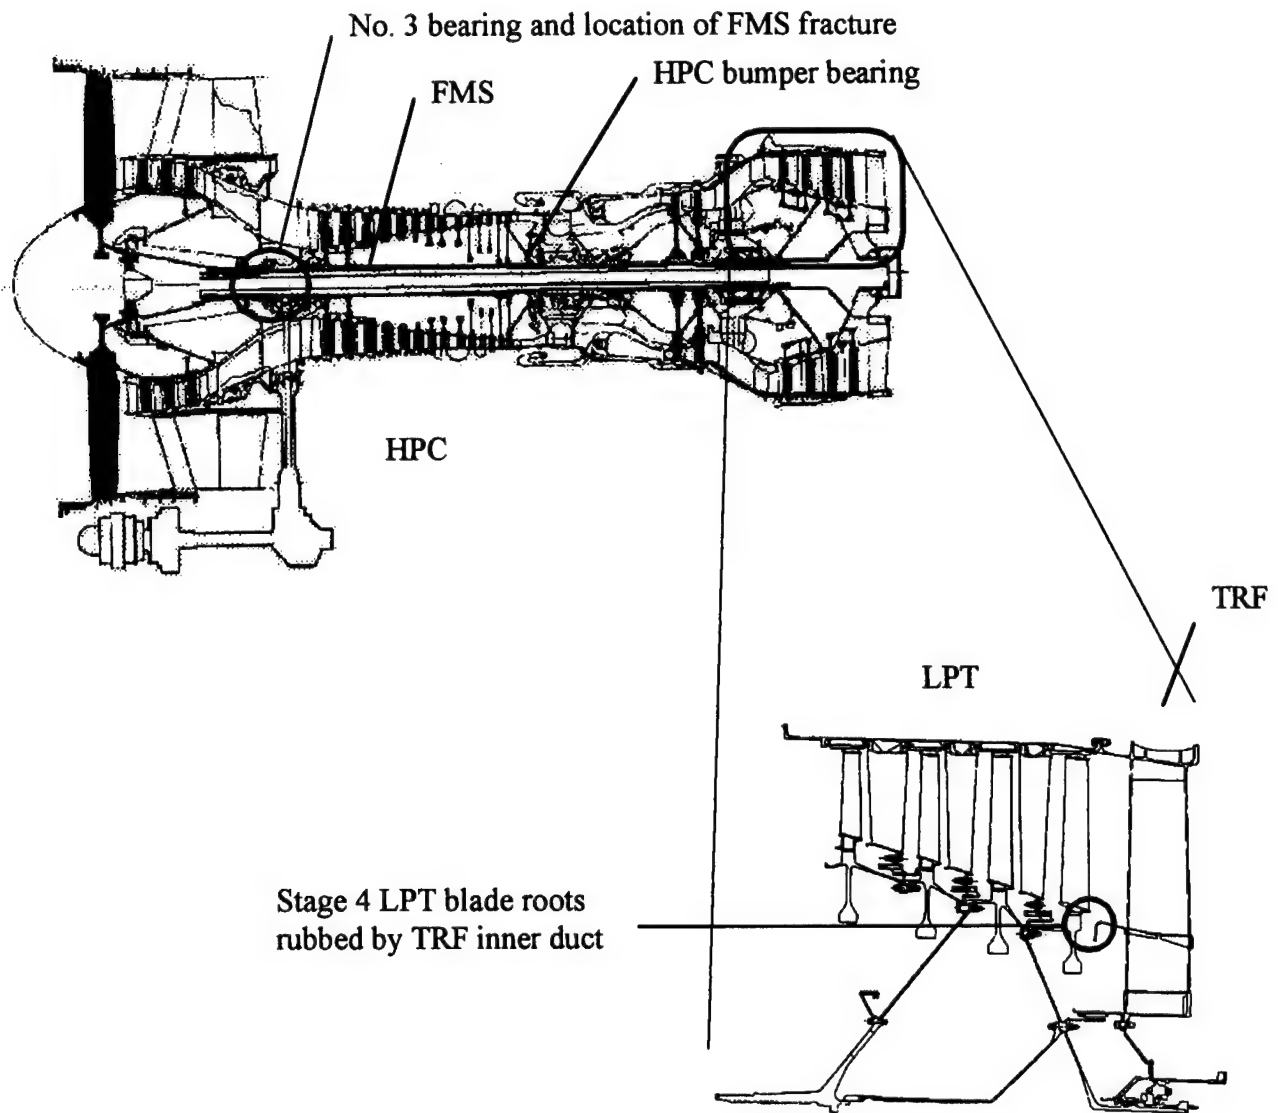
Figure 1. Cross section of CF6-50 engine and expanded view of LPT module

Disassembly of the engine, serial number (SN) 455-954, at GE's Engine Maintenance Center, Ontario, California, under the direction of the National Transportation Safety Board, revealed that the fan midshaft (FMS) was fractured circumferentially, just aft of the No. 3 (roller) bearing. Although the No. 3 bearing was damaged, the damage was typical of secondary damage that would have occurred late in the engine failure sequence.

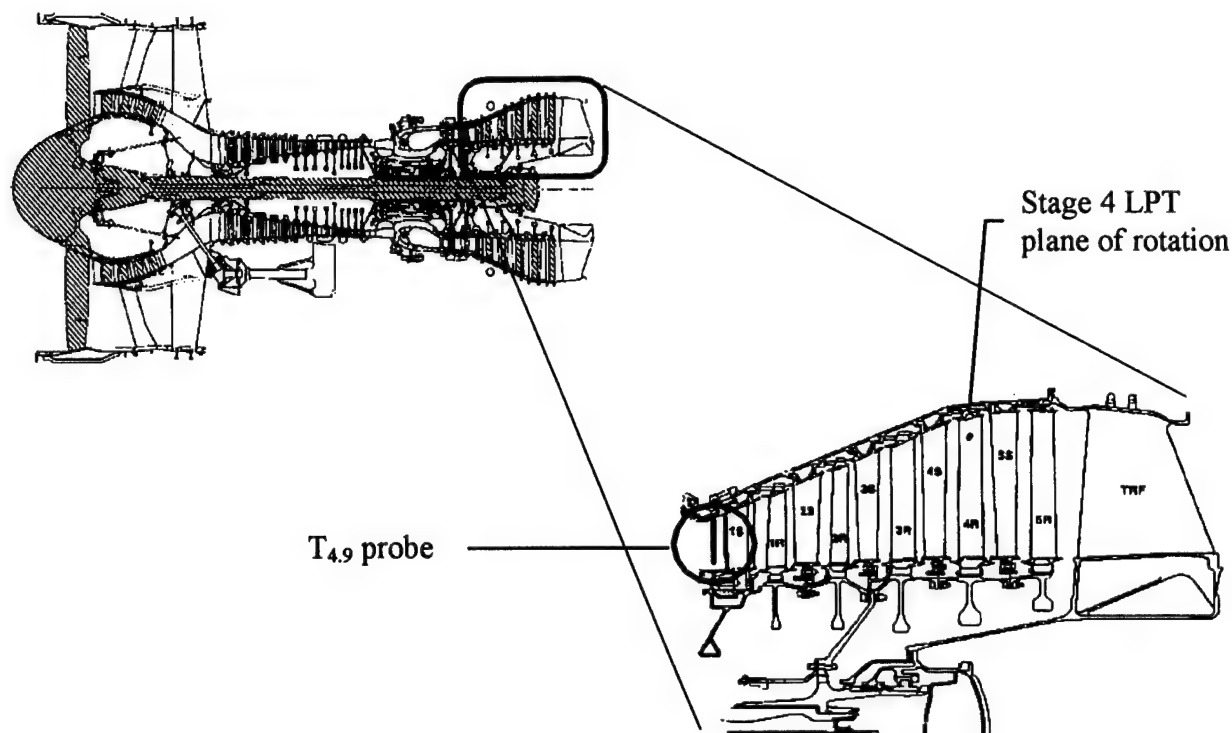
Figure 2. Cross section of CF6-80C2 engine and expanded view of LPT module

The Safety Board is aware of a similar event that occurred on September 5, 1997, when a Federal Express (FedEx) McDonnell Douglas MD-11 airplane, equipped with GE CF6-80C2 engines, had an uncontained LPT failure in the plane of the stage 4 LPT rotor. The disassembly of the FedEx engine showed that a stage 1 LPT airseal segment had broken loose from the LPT case and passed through the gaspath causing the breakage of the downstream turbine blades. As in the American Airlines LPT, the damage in the FedEx LPT rotor was more extensive downstream along the gaspath. The evidence shows that both the American Airlines and FedEx LPT cases withstood the initial containment challenge of the separation of an LPT blade; however, neither case could withstand the loads imparted by the resultant mass of broken LPT airfoils. This suggests that the design containment capability of the LPT case is inadequate.

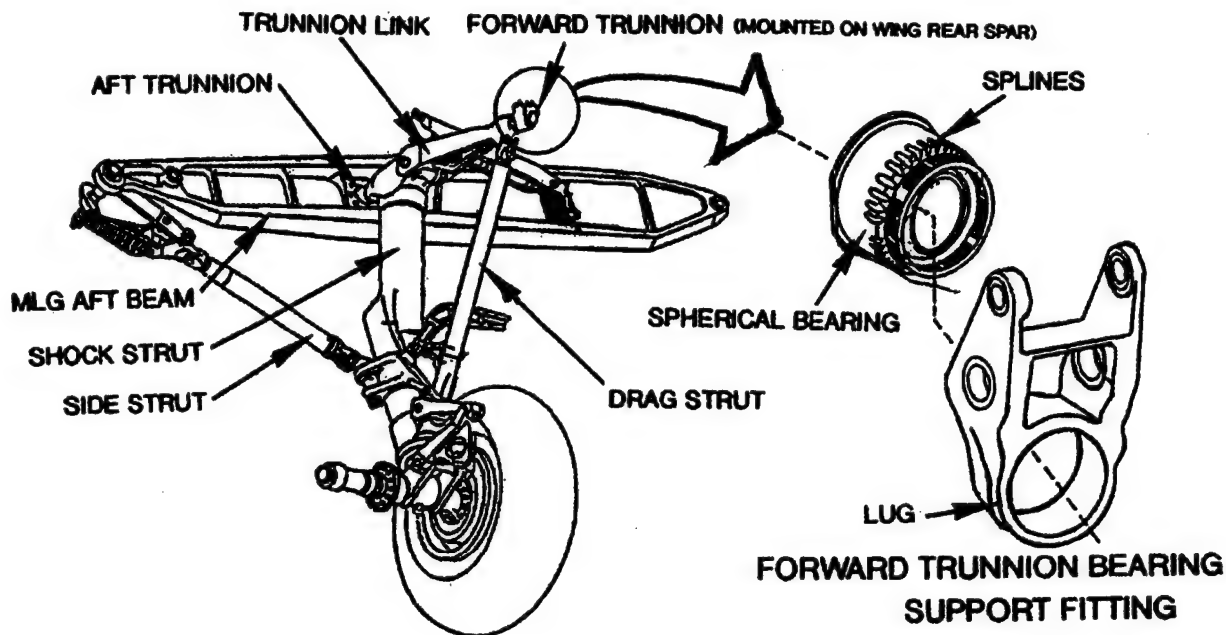
Figure 1. Boeing 727 Main Landing Gear Assembly

The right MLG of the B-727 is a conventional, two-wheel landing gear with three support points: the forward trunnion, the aft trunnion, and the side strut (see figure 1). A trunnion link is mounted between the shock strut and the rear spar. The aft end of the trunnion link is pinned to the shock strut, and the forward end pivots in a spherical bearing mounted in the forward trunnion bearing support fitting.¹ The spherical bearing has external splines that are used for locking the bearing assembly and retaining it within the support fitting lug. The splines contact a portion of the inner surface of the lug, leaving the gaps between the splines exposed to possible corrosion. The trunnion bearing support fitting is a round housing made from 4330M steel. The inner bore of the housing has chrome electroplating, which is the bore's primary means for corrosion protection. The fitting is mounted on the rear spar of the wing with high-strength bolts.

Examination of the trunnion bearing support fitting at the Safety Board's materials laboratory revealed corrosion at the forward edge of the fitting's lug in many of the exposed areas between the bearing splines. Fatigue cracking emanated from two locations within a severely corroded area, and intergranular stress corrosion cracking (SCC) stemmed from the fatigue cracking. This corroded area was 0.15-inch wide by 0.37-inch long by 0.07-inch deep. The fracture was caused by a combination of fatigue cracking and SCC.

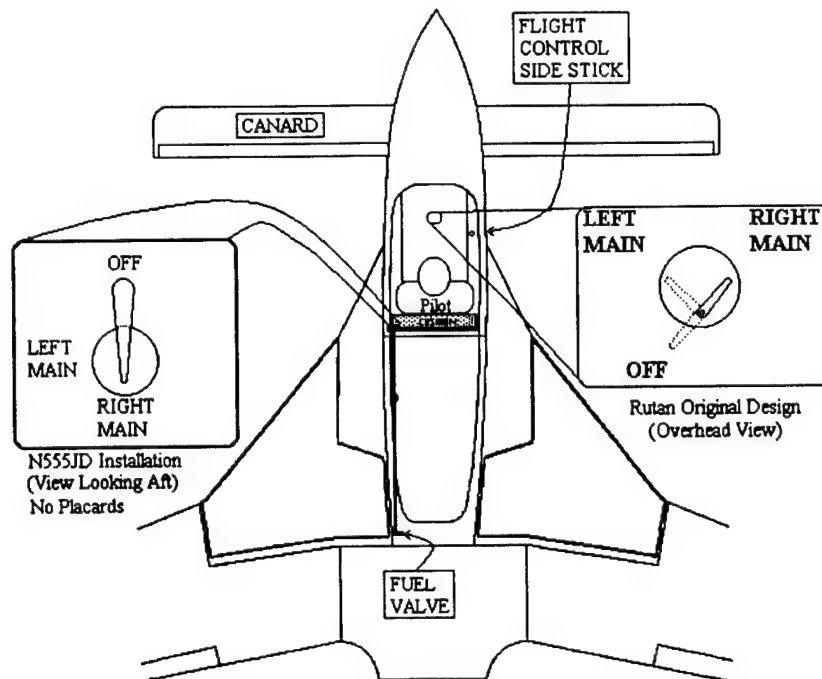
Figure 1—Comparison of fuel selector handle locations in Long-EZ

¹⁰ Although the accident airplane was equipped with sight gauges, which were part of the original design, it also had a fuel totalizer installed in the front instrument panel that required pilot entry of the starting fuel amount. Witness statements provide no evidence that the totalizer was used, and the checkout pilot stated he was not familiar with it and did not provide any instruction on its use.

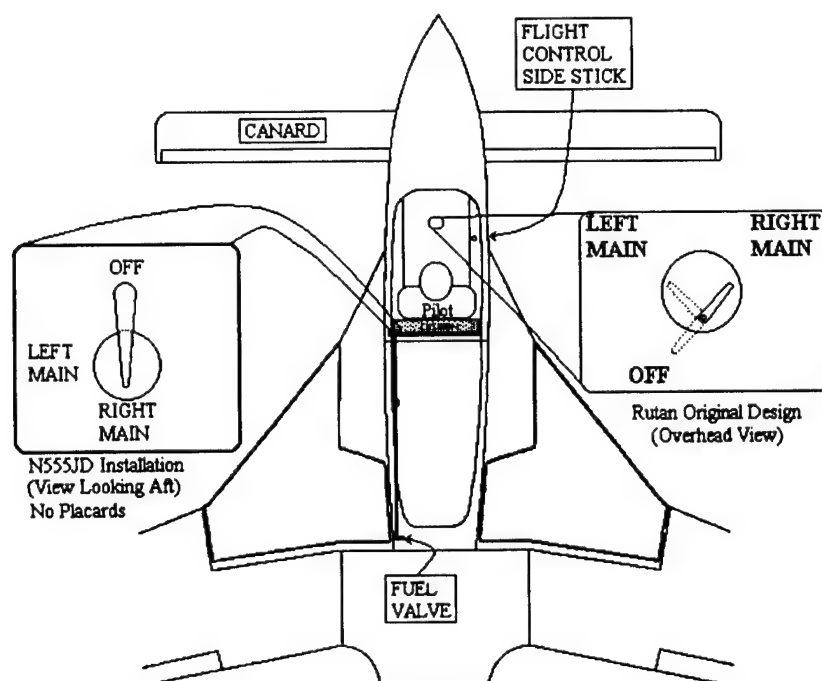
Figure 1—Comparison of fuel selector handle locations in Long-EZ

¹⁰ Although the accident airplane was equipped with sight gauges, which were part of the original design, it also had a fuel totalizer installed in the front instrument panel that required pilot entry of the starting fuel amount. Witness statements provide no evidence that the totalizer was used, and the checkout pilot stated he was not familiar with it and did not provide any instruction on its use.

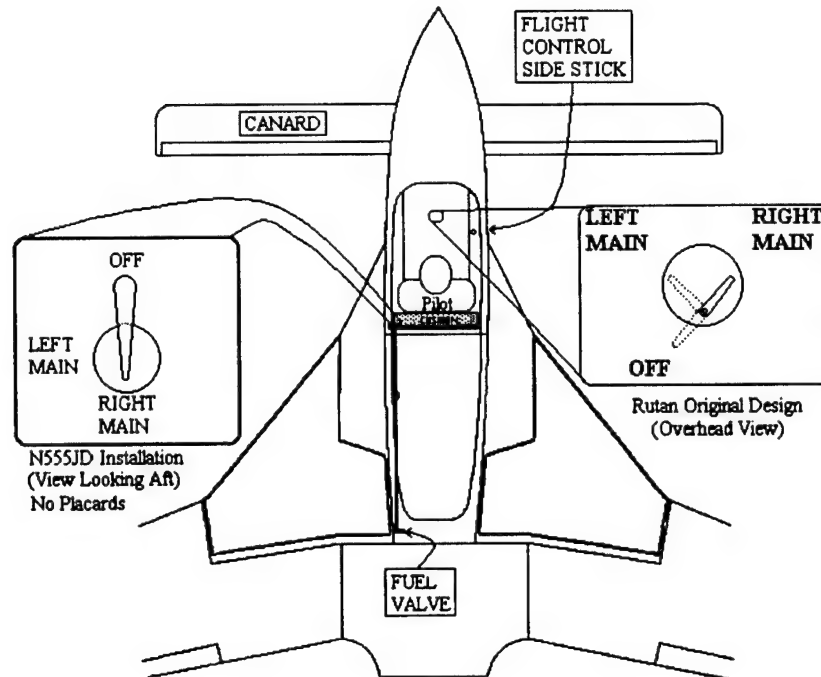
Figure 1—Comparison of fuel selector handle locations in Long-EZ

¹⁰ Although the accident airplane was equipped with sight gauges, which were part of the original design, it also had a fuel totalizer installed in the front instrument panel that required pilot entry of the starting fuel amount. Witness statements provide no evidence that the totalizer was used, and the checkout pilot stated he was not familiar with it and did not provide any instruction on its use.

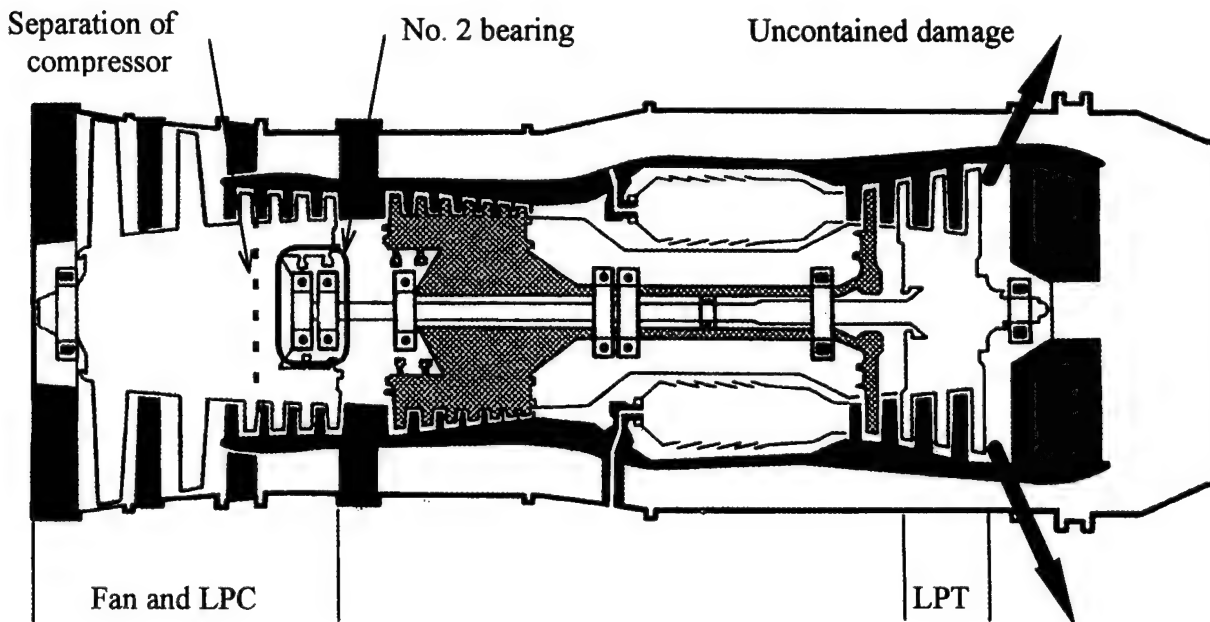
Figure 1. JT8D engine

The JT8D engine's low pressure rotor system is made up of a two-stage fan, which consists of the 1st and 2nd stage fan rotors,³ and a four-stage low pressure compressor (LPC), which consists of the 3rd, 4th, 5th, and 6th stage compressor rotors. The two-stage fan and four-stage compressor are joined to the three-stage LPT, which consists of the 2nd, 3rd, and 4th stage turbine rotors, by a drive shaft, all of which rotate as one unit under normal conditions (see figure 1). The examination of the incident engine revealed that the 1st and 2nd stage fan rotors and the 3rd stage compressor rotor rotated together but independently from the remainder of the low pressure rotor system from the 4th stage compressor rotor rearward. The examination also showed that the 2nd, 3rd, and 4th stage LPT disks were intact but that all of the LPT blades were fractured adjacent to the blade root platforms, and most of the LPT vanes were missing. Although the engine was outfitted with an LPT containment shield, as required by Airworthiness Directive (AD) 94-20-09, the containment shield was broken into three pieces, and the engine was cut in two just aft of the LPT by liberated LPT blades.⁴

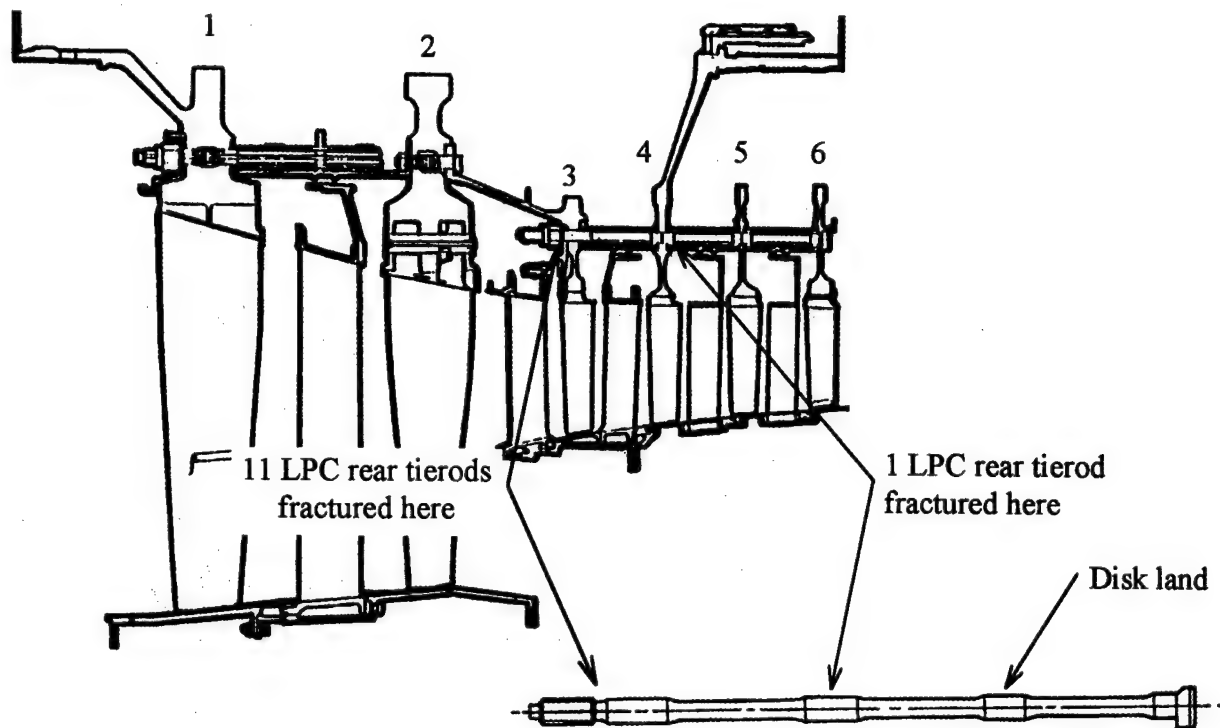
Figure 2. Cross-section of the JT8D fan and LPC and view of an LPC rear tierod

The 4 stages of the JT8D engine's LPC are held together by 12 long bolts, called LPC rear tierods, that pass through alternating disks and spacers (see figure 2). The disassembly of the Royal Airlines LPC revealed that one LPC rear tierod, part number (PN) 789550, was fractured transversely across the tierod's 4th stage compressor disk land.⁵ The entire fracture face on the

tierod had surface corrosion, suggesting that the tierod had been broken for some time. Because of overstress, the 11 remaining LPC rear tierods were fractured at their forward ends between the 3rd stage compressor disk lands and the tierod nut threads. All six of the recovered tierod nuts and ends had numerous pockmarks on one side, and the tierod ends were bent away from the pockmarks. The pockmarks and bending damage suggest that after the initial tierod fractured and was liberated from the compressor, it tumbled around in the cavity at the front of the LPC and impacted the other tierod nuts and ends until they eventually fractured, causing the compressor to separate between the 3rd and 4th stage rotors and the engine to fail. Eleven equally spaced fan exit vanes had the imprints of the tierod nuts on the leading edge, indicating that the 11 remaining tierods fractured simultaneously when the engine failed.

The Safety Board's examination of the LPC rear tierod with the corroded fracture face revealed that a fatigue fracture originated from a small area of galling⁶ on the 4th stage compressor disk land. On July 7, 1982, as a result of 33 LPC rear tierod fractures at the 3rd and 4th stage disk land locations that caused damage in JT8D engines, P&W issued Service Bulletin (SB) 5407.⁷
